LOWER HOUSATONIC RIVER BASIN  
SHELTON, CONNECTICUT

TRAP FALLS RESERVOIR DAM  
CT 00091

PHASE I INSPECTION REPORT  
NATIONAL DAM INSPECTION PROGRAM

AUGUST 1978

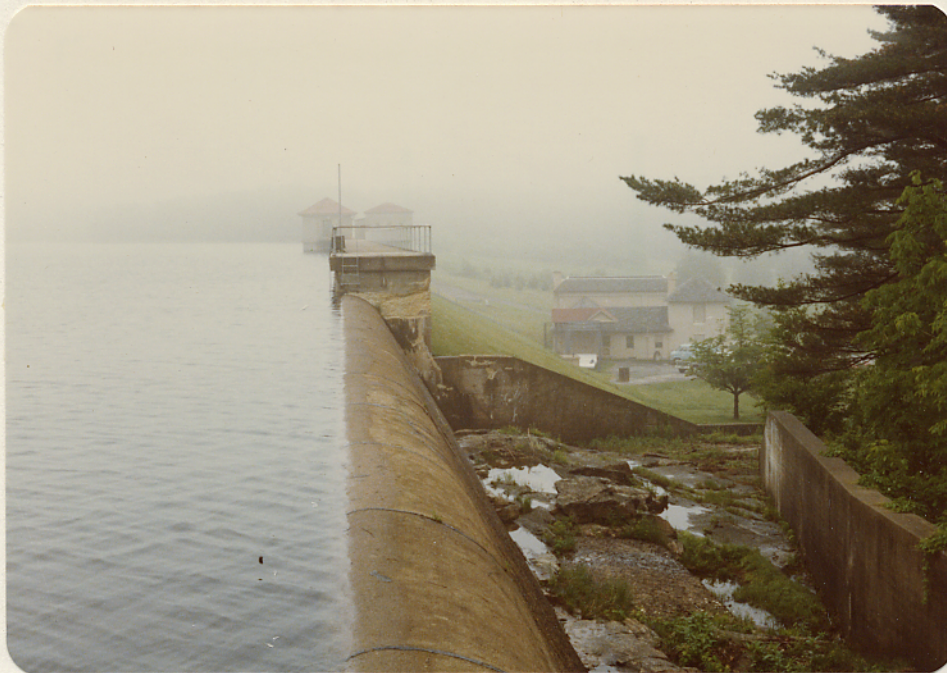
PHOTO NO.1 - General view of spillway and channel with downstream facilities in background.

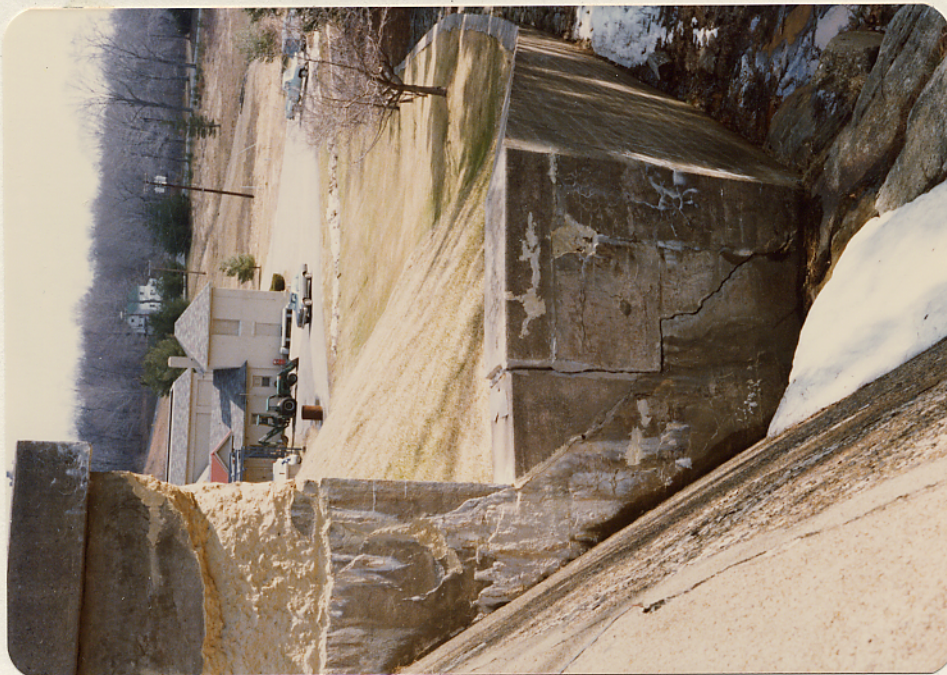
Spillway - The spillway was excavated in bedrock, which is exposed at the right abutment and immediately downstream of the spillway. There is a minor seep through the bedrock observed at the left side and a few feet downstream of the spillway. The water is clear. The right wingwall of the spillway does not have weep holes, and it is in good condition. The left wall has moved into the spillway channel apparently by rotation on its foundation. This is probably due to a combination of freezing pressures and water pressures which, because of the absence of weep holes through the wall, are superimposed on the existing earth pressures.

1. The left wing wall of the spillway has apparently moved continuously, and references to the movements and repair of the cracks are made in several prior inspection reports. The movements to date are not large enough to endanger the safety of the wall; however, the continuous attention required by the wall movements would indicate that some remedial action should be taken in the future, such as installation of weep holes and a drainage layer against the wall to reduce water pressures and also to reduce pressures due to freezing soil behind the wall.

PHOTO NO.2 - Spillway deterioration and cracking of channel retaining wall.

1. The movements of the left wingwall of the spillway should be monitored, and if the rate of movements indicate it necessary, remedial action should be taken, such as the installation of weep holes and placement of a properly filtered layer of free draining material against the back of the wall. Should damage to the wall increase, it may also become necessary to perform repair work on the wall itself.

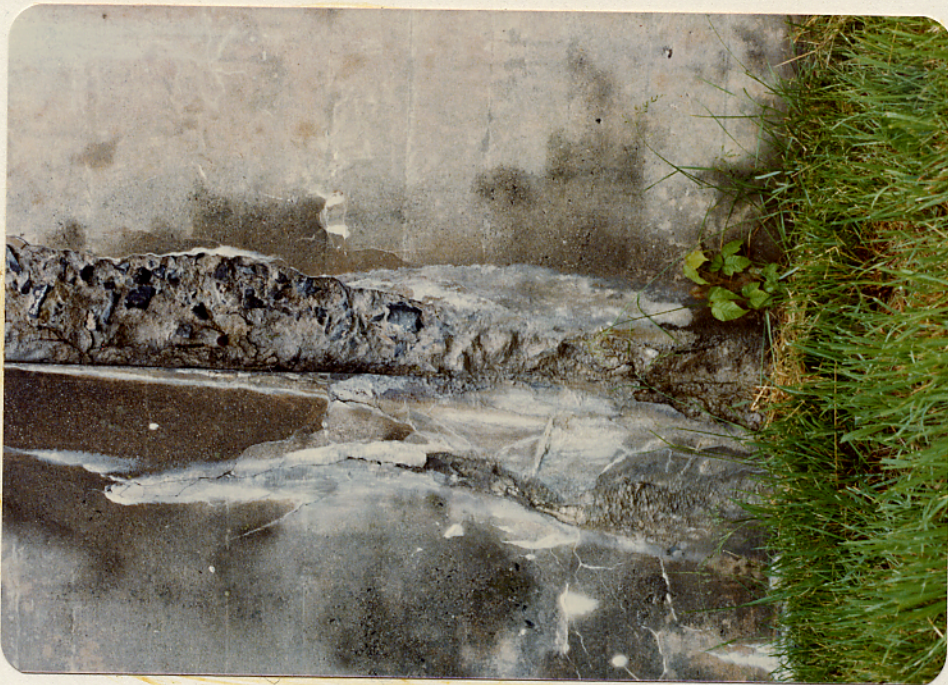
Crest - The concrete crest of the dam in general appears to be in good condition. Some seepage has occurred at construction joints on the downstream face of dam resulting in efflorescence and spalling of concrete surfaces. Heavy spalling has also occurred at the right end of the dam adjacent to the spillway. There have been movements of a block of concrete at the end of the concrete dam wall. There is no visual evidence of these movements being related to foundation movements.

PHOTO NO.3 - Spalling and efflorescence at downstream face of dam.

3. Maintenance of spalled concrete where it occurs at construction joints and concrete surfaces should be carried out on a regular basis. Leaching of water through construction joints and cracks in the concrete surfaces should be repaired to prevent further deterioration of the concrete.

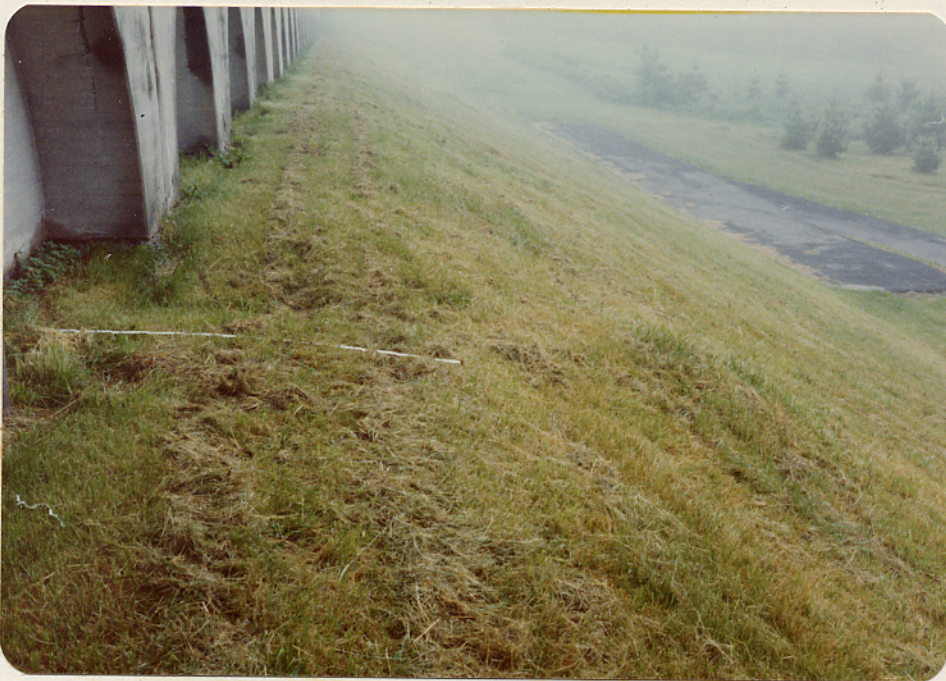
Downstream Slope - The downstream slope of the earth embankment is grass covered and is, in general, in good condition. At several locations some minor sloughing of the slope has taken place. At one such area in front of the 23rd concrete wall arch (from the left abutment), the depression and bulge are between 6 in. to 2 ft in depth and height, and each is about 4 ft. by 4 ft in area. The soil at the top of the embankment is soft and has local depressions at several locations, generally in the inside of the arches, i.e. next to the concrete buttresses. No seeps, wet or spongy areas were observed on the downstream embankment slope. However, the previous night it had rained, and thus minor wet areas or seeps could not have been detected.

2. The minor sloughing of the downstream slope and the soft area, and depressions on the top of the earth embankment, probably indicate the result of leaks through the concrete wall above and below the level of the top of the embankment. However, there are no indications of a significant stability problem of the earth embankment as a result of such leaks.

PHOTO NO.4 - General view of downstream embankment. Note area of localized minor sloughing.

2. Minor sloughing of the ground surface on the downstream face and near the top of the embankment should be observed periodically to assure that no further movement is occurring.
